Manhole Inspection Summary

Manhole # S15GG2012MH

Inspection ☐ Is Incomplete Rating: **4) Poor**

Location Address: **1901 MAYWOOD AVE**

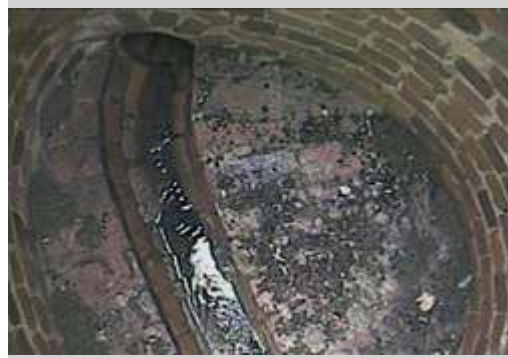
Top View

Evidence of surcharge - Bench debris.
Channel debris.

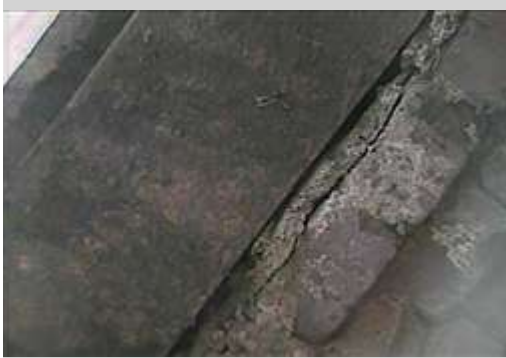
Defect

Frame leaks. Adjustment deterioration
and infiltration.

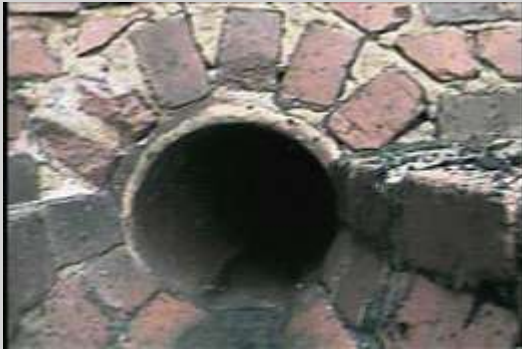
8 in. Circular Gravity Sewer Pipe Out @ 12 O'Clock

Infiltration: **Evidence** Pipe Seal Cond: **Unknown**

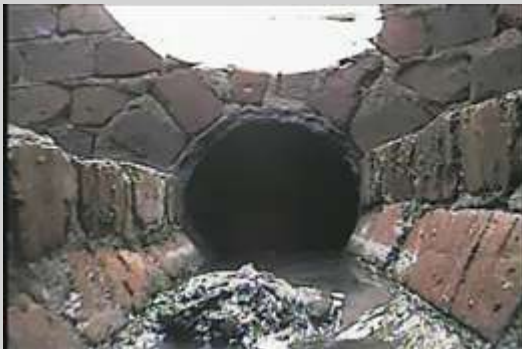
8 in. Circular Gravity Sewer Pipe In @ 6 O'Clock

Barrel deterioration and infiltration. Channel deterioration.

Infiltration: **Evidence** Pipe Seal Cond: **Unknown**
